Report No. 06-1802

***Laboratory Testing:
Salt Fog Exposure – ASTM B 117-03
On Fluorokote #1 Stock***

Two (2) raised-face FRP piping flange assemblies were delivered to ITI Anti-Corrosion, Inc. for exposure to 2200±24 hours of *ASTM B 117-03; Standard Practice for Operating Salt Spray (Fog) Apparatus*.

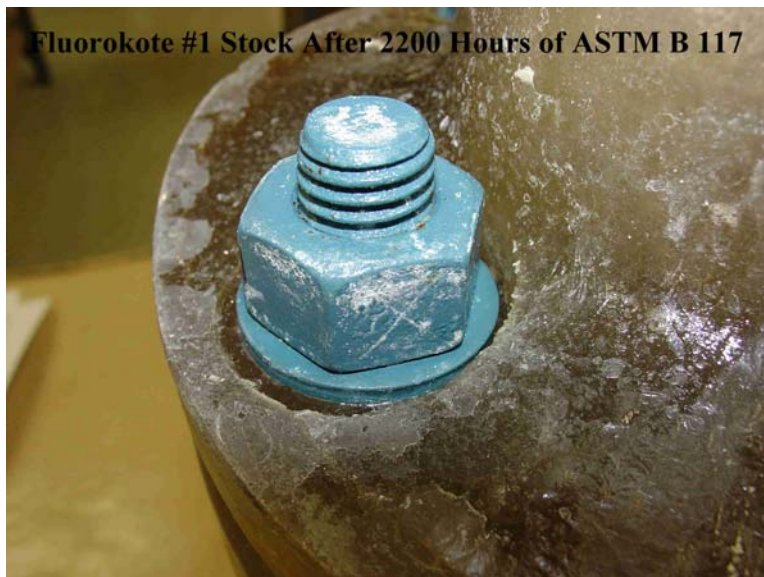
The Horizontal/Hand Torque assembly was disassembled at the completion of the exposure with the nuts being easily unthreaded by hand with little effort.
